3.0 Canonsburg, Pennsylvania, Disposal Site

3.1 Compliance Summary

Figure 3-1. 2003 Annual Compliance Drawing for the Canonsburg, Pennsylvania, Disposal Site

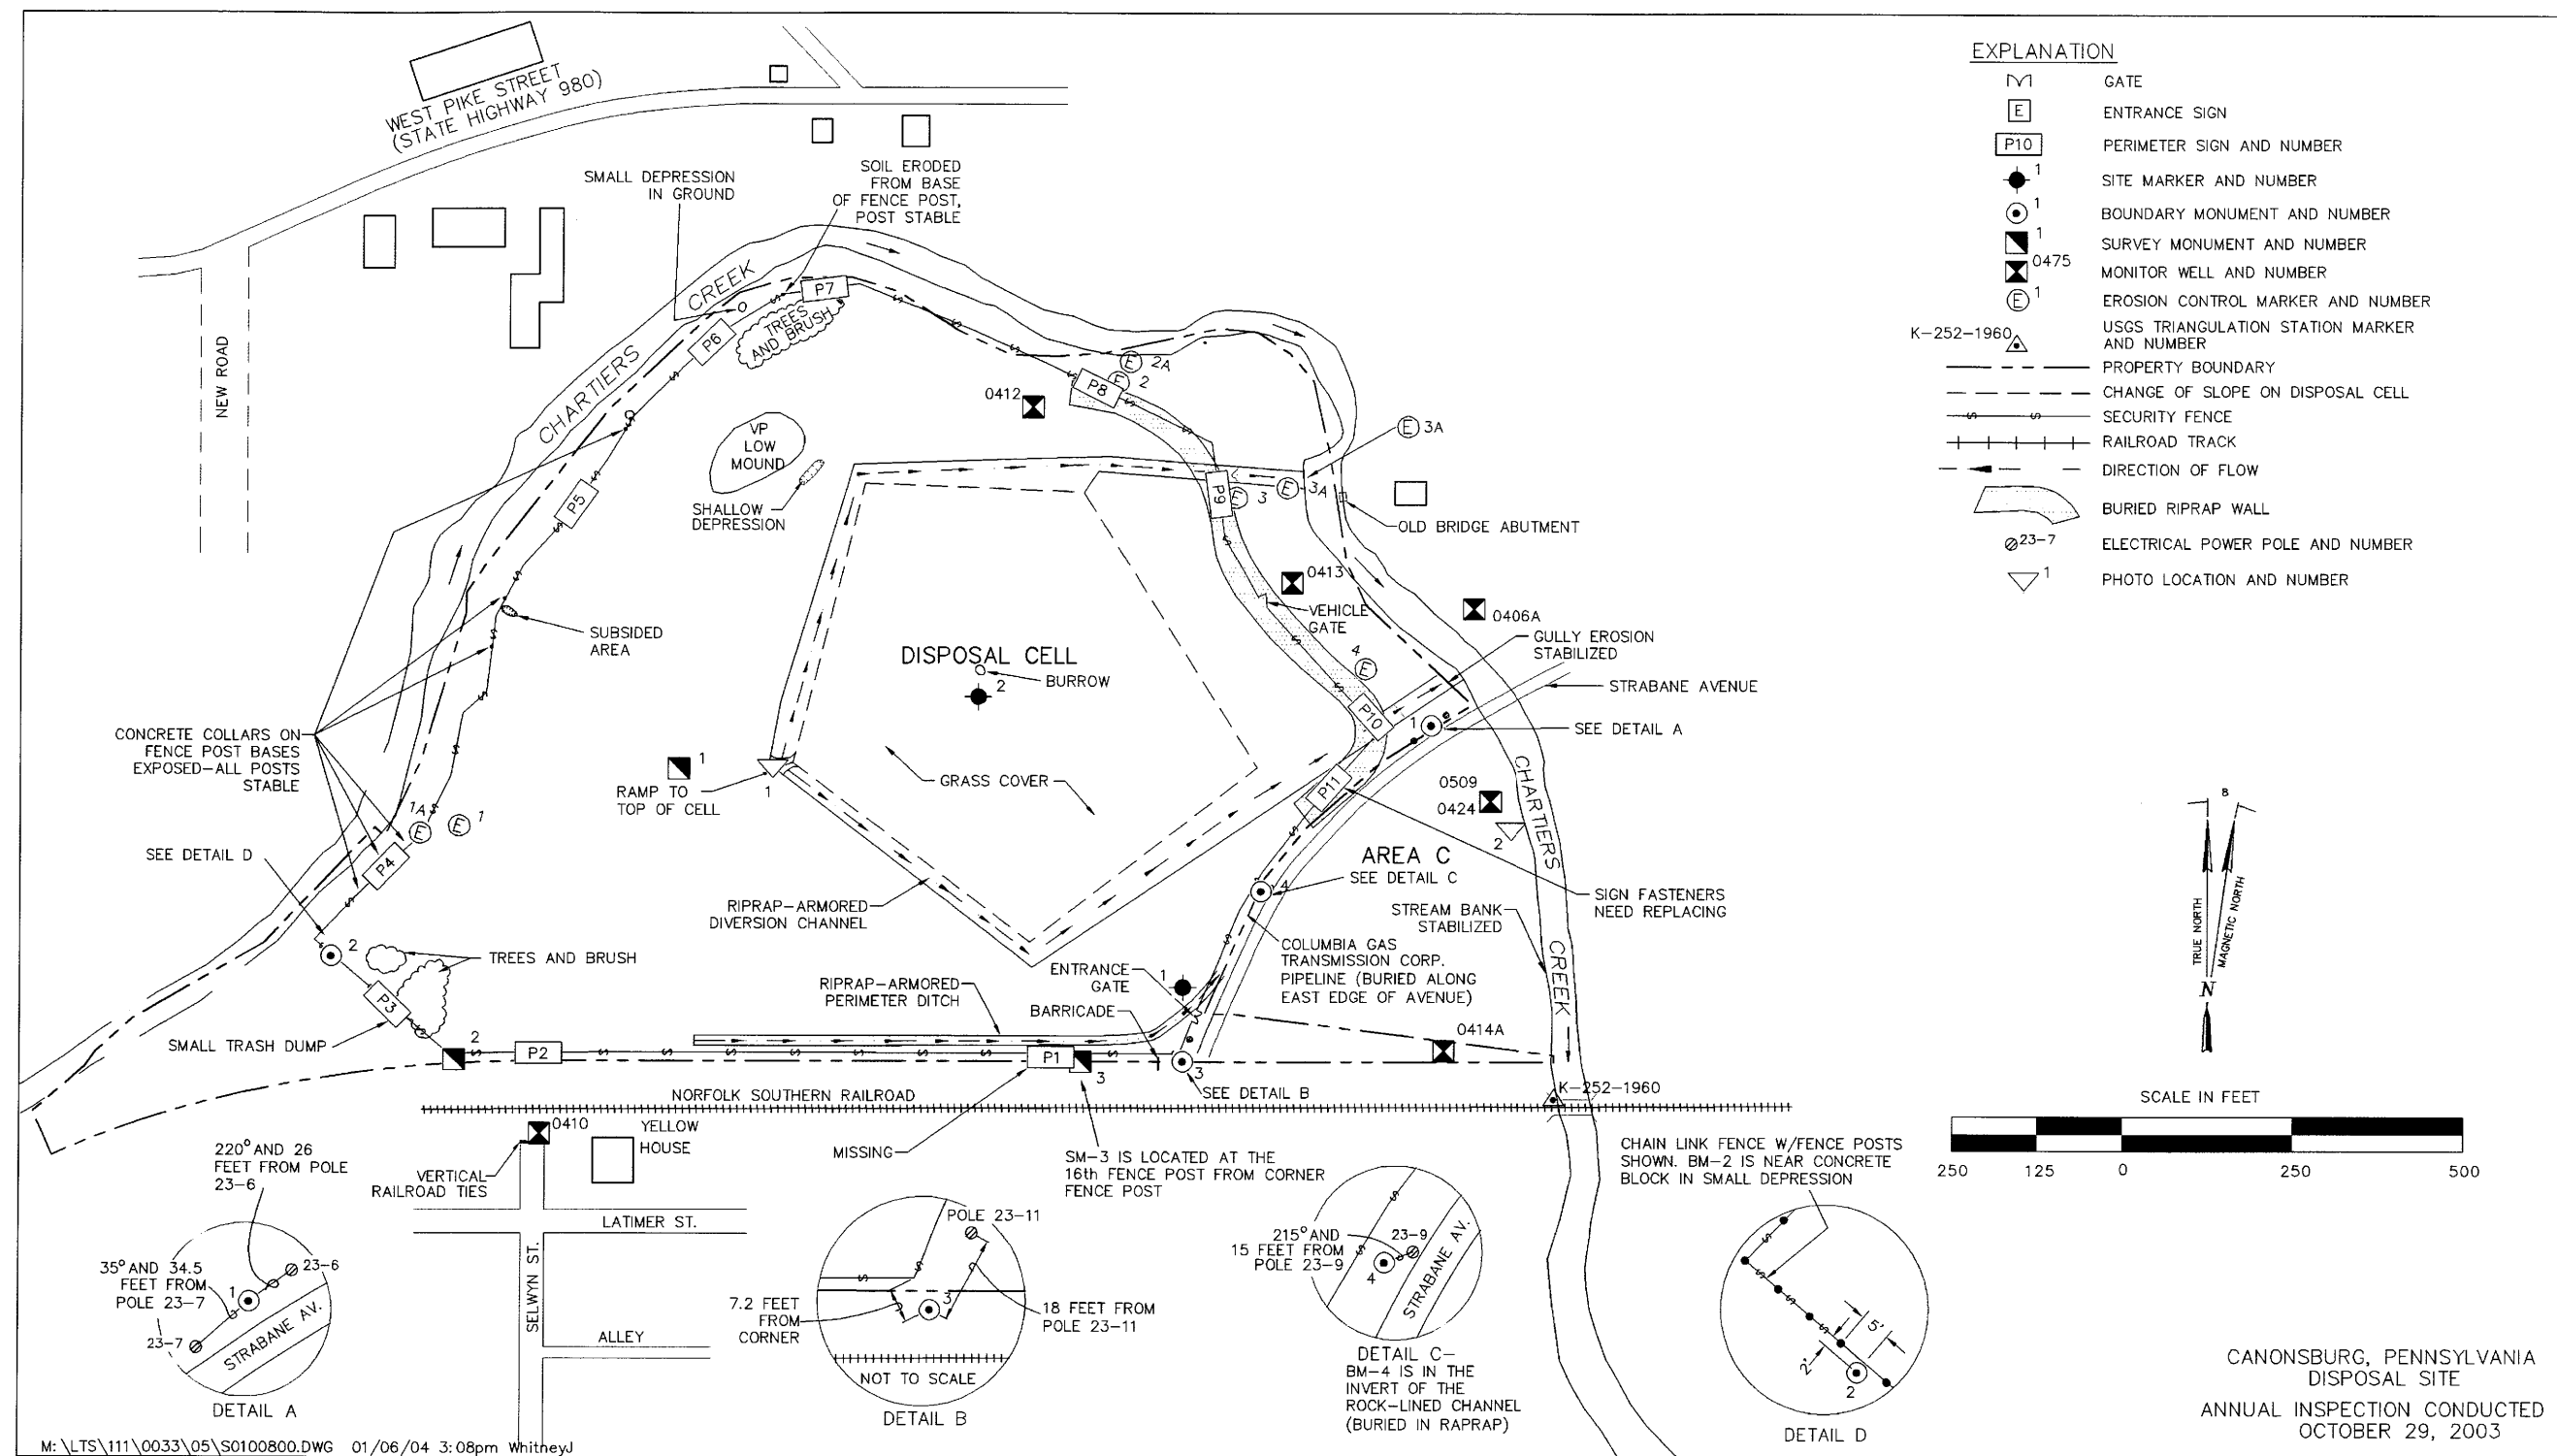
The site, located between the communities of Canonsburg and Houston, Pennsylvania, was inspected on October 29, 2003. Features and photograph locations (PLs) mentioned in this report are shown on Figure 3-1. Numbers in the left margin of this report refer to items summarized in the Executive Summary table.

The monitoring network consists of six wells completed in the shallow unconfined aquifer and three surface water locations in Chartiers Creek (Figure 3-1). The Long-Term Surveillance Plan required sampling for two years after the site was licensed. This requirement was met by sampling in 1996 and 1997. However, because the concentration of uranium in some wells remains above the maximum concentration limit of 0.044 milligrams per liter (mg/L), DOE continues to monitor these locations annually. DOE also has monitoring requirements, including four of the above wells (three of which are considered point of compliance wells) and one surface location (point of exposure), for at least 5 years (through 2004), to verify compliance with alternate concentration limits established by the Ground Water Compliance Action Plan. The Long-Term Surveillance Plan is being revised to combine these separate requirements into a comprehensive site-wide monitoring program.
